UNITED STATES ENVIRONMENTAL PROTECTION AGENCY

SUBJECT: Inspection Report Transmittal to Ledgeview Farms, LLC

On April 9, 2015, EPA conducted an inspection of your facility, Ledgeview Farms in De Pere, Wisconsin. The purpose of the inspection was to evaluate compliance with the Clean Water Act (CWA) and Administrative Order V-W-13-AO-22. Ledgeview Farms is a large Concentrated Animal Feeding Operation (CAFO) as defined in 40 C.F.R. § 122. During the inspection, we observed violations of the CWA and Administrative Order. The CWA and Order requires you to immediately cease all unauthorized discharges.

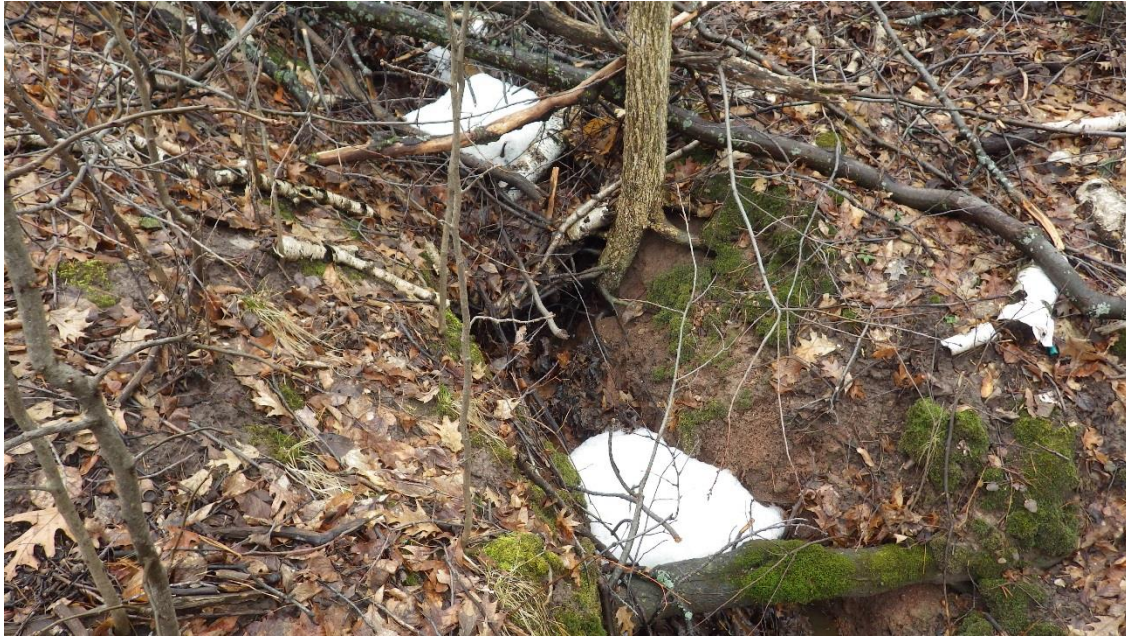
Description: The drainage pathway flowed to the unnamed tributary.

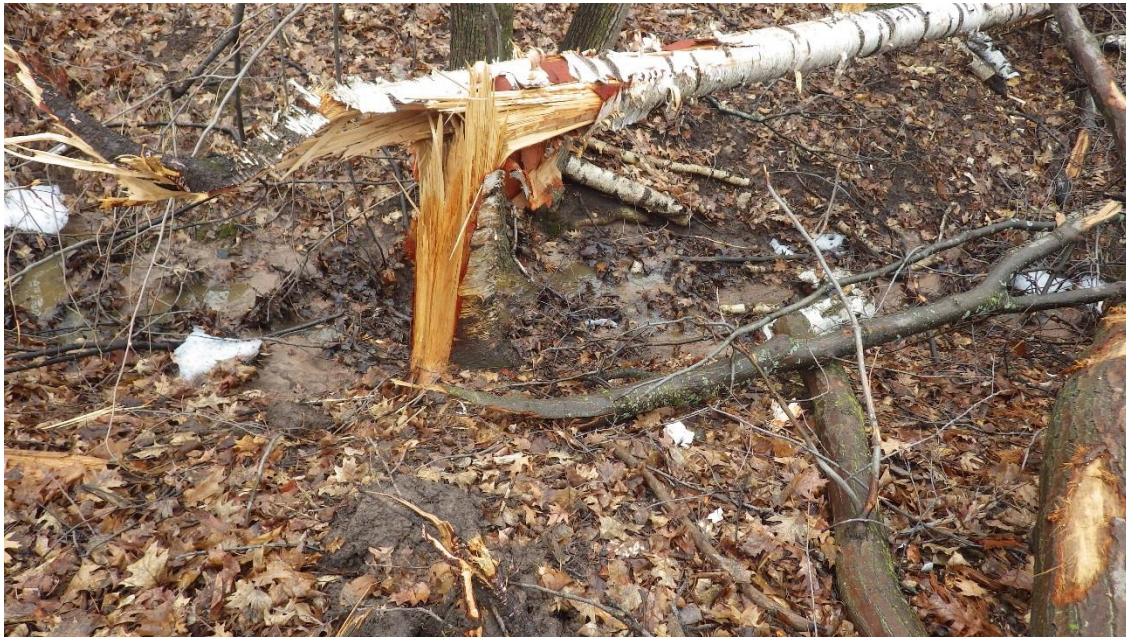
201: RIMG0210

Description: The drainage pathway flowed to the unnamed tributary. Foam was observed in the drainage pathway.

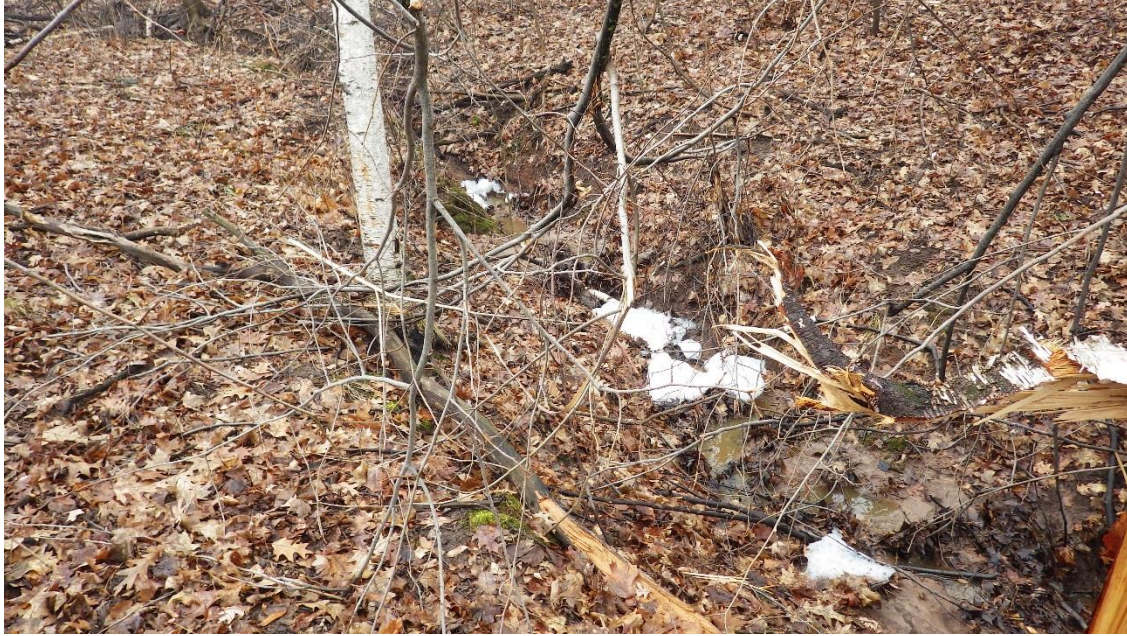
202: RIMG0211

Description: The drainage pathway flowed to the unnamed tributary. Foam was observed in the drainage pathway.

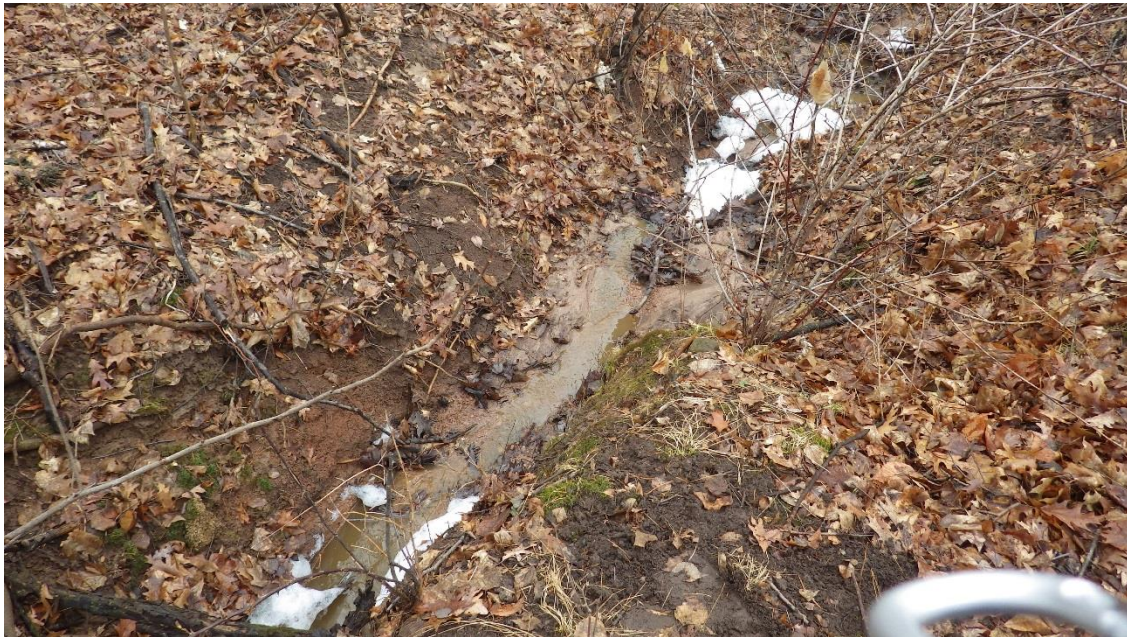
203: RIMG0212

Description: The drainage pathway flowed to the unnamed tributary. Foam was observed in the drainage pathway.

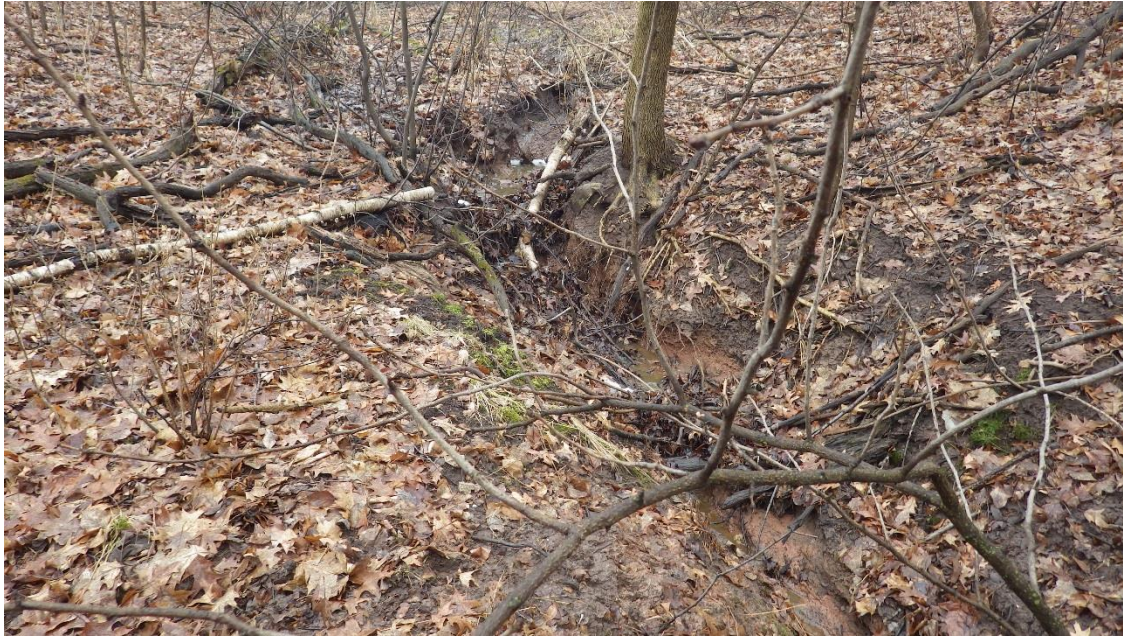
204: RIMG0213

Description: The drainage pathway flowed to the unnamed tributary. Foam was observed in the drainage pathway.
